LINCOLN, TENN.  
N3500-W8630/7.5  
1949  
PHOTO-REVISED 1972

## LANDSLIDES AND RELATED FEATURES

OF THE LINCOLN, TENN. QUADRANGLE

U.S. Geological Survey  
Open File Map 82-750 (A-12)

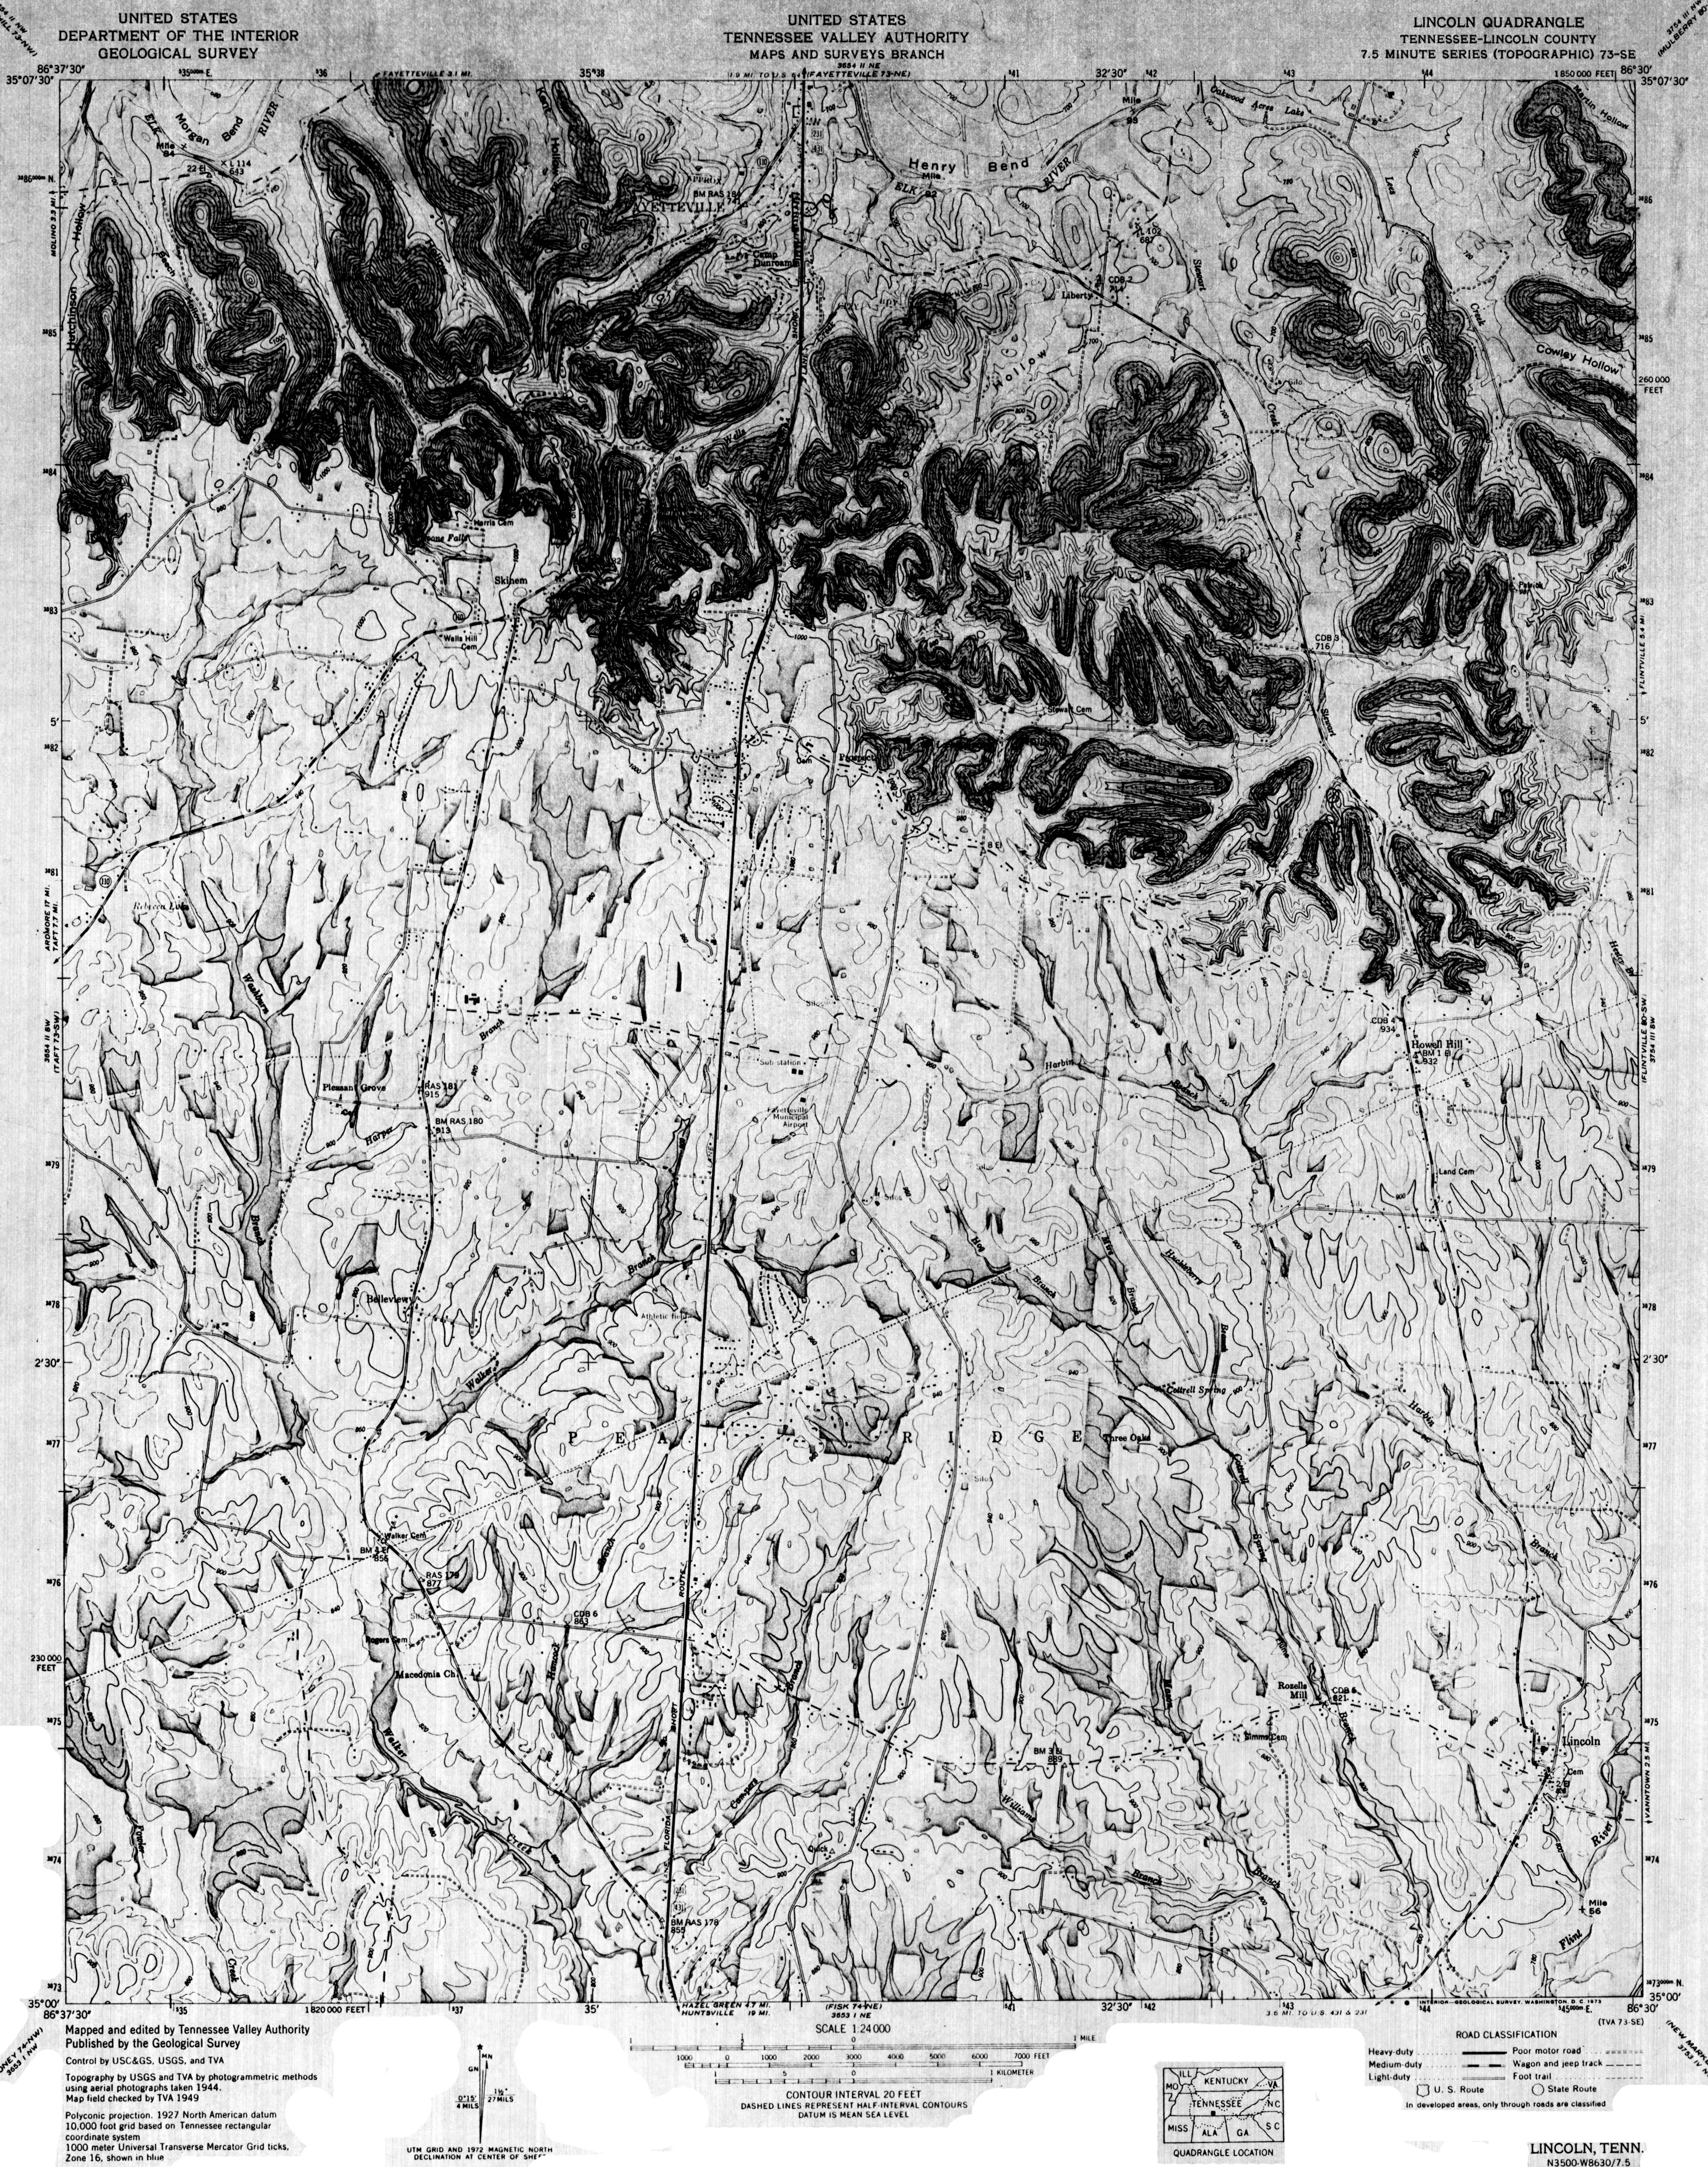
Landslides and related features interpreted  
from aerial photographs:

1:40,000 (black and white) 1976

Photointerpretation and field check 1980-1981

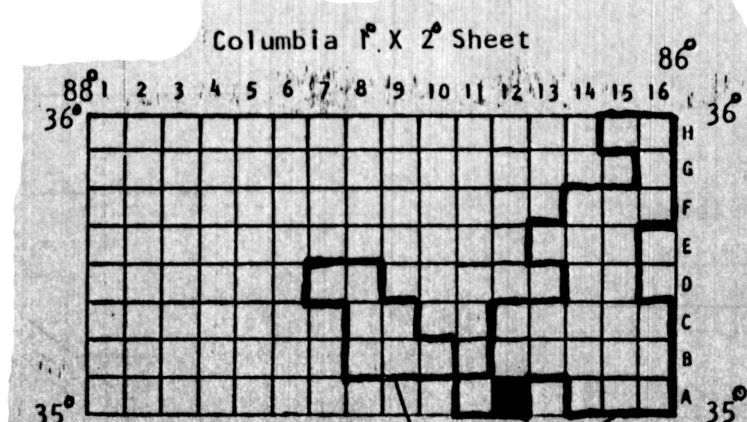
The first five digits of the open file number designate the  
specific 1:250,000 scale map sheet of which this quadrangle  
is a part. The last two digits designate the position of the  
quadrangle in a subdivision of the 1:250,000 scale map based  
on rows and tiers shown in the diagram to the right. The  
location of this quadrangle is shown by the black square.
